MONITORING OF A MULTI FUNCTIONAL SUBMERGED GEOTEXTILE REEF BREAKWATER

Abstract: A large reef has been constructed offshore from Narrowneck on the Gold Coast, Queensland, Australia. The reef provides a submerged, low visual impact, coastal control point to stabilize the nourished northern Gold Coast beaches. As the reef is in a popular tourist and surfing area, it has also been designed and constructed to enhance recreational amenity. For safety and cost efficiency, the reef has been constructed of very large sand filled geotextile units. Experience with the design and construction of such structures is limited and the inclusion of improved surfing as secondary design criteria increases the complexity. To facilitate evaluation and modifications to the reef there is a comprehensive monitoring program, which includes the use of ARGUS video imagery to assess the changes in the shoreline related to wave conditions at the wave rider buoy nearby. Divers are studying the physical performance of the sand filled geotextile containers, as well as the extent and diversity of the marine ecosystem which has exceeded expectations. There have been a number of storm wave events during the monitori

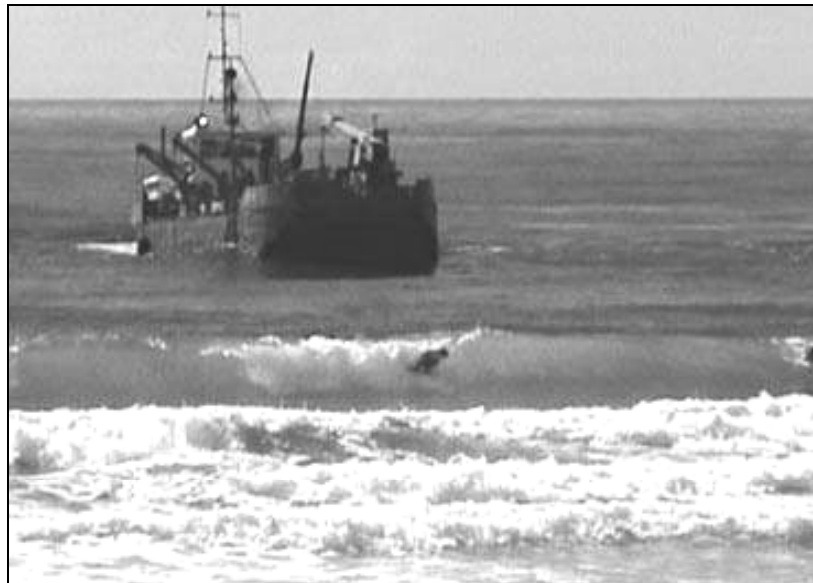
Photo 1. Dredge placing “sand bags” near surfers

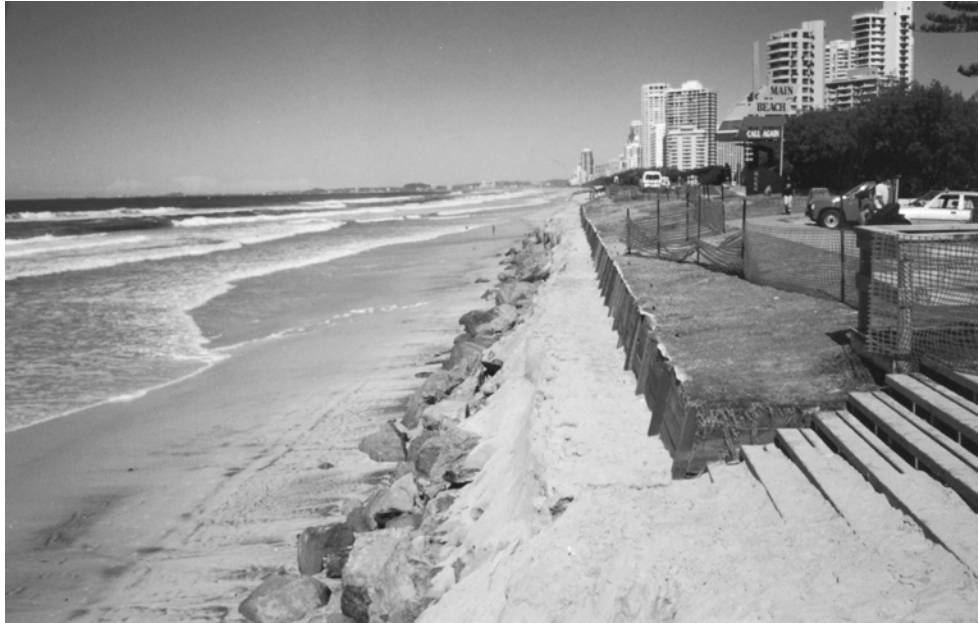
The Narrowneck reef is constructed on an open sandy coast, in an area with an average $H_s = \sim 1\text{m}$, and an average longshore transport rate of $\sim 500\text{m}^3/\text{yr}$. The maximum tidal range is $\sim 2\text{m}$. Since monitoring commenced in 1999, there have been 13 storm wave events with $H_m > 5\text{m}$ to 31st July 2002. Prior to construction the beach at Narrowneck was narrow, and erosion back to the boulder wall occurred regularly (Photo 2). Since nourishment and reef construction a wide beach has been maintained (Photo 3).

Photo 2. Narrowneck 1996

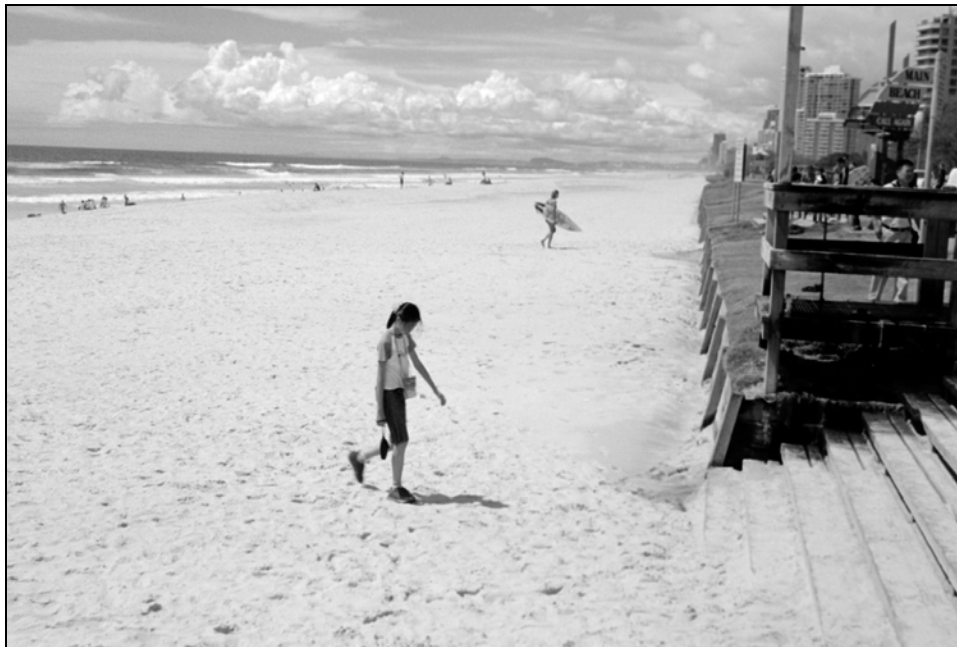
Photo 3. Narrowneck 2002

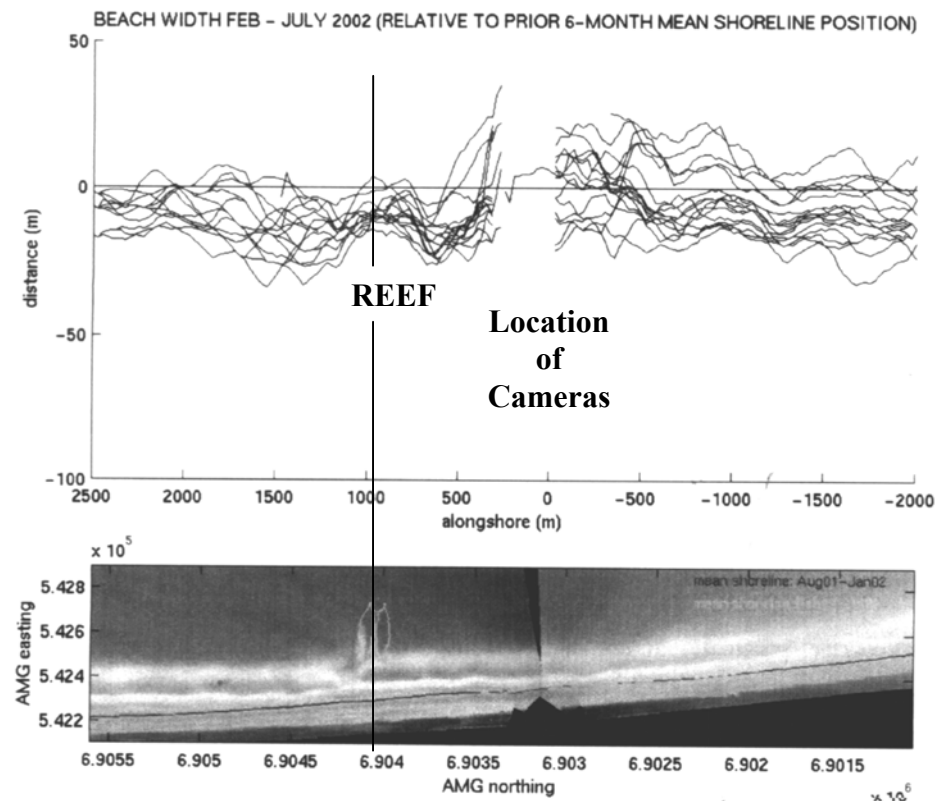
From the video imaging, it was concluded that 3.5 years after sand nourishment commenced at the northern Gold Coast in February 1999, and 2 years after the nourishment program was completed in mid 2000, an additional 20 – 30 m of beach has been achieved along approximately 2 km of the coastline, relative to the adjacent unnourished beaches to the north and south. The unnourished beaches have accreted some 10 – 20 m during this time, with the net result that the nourished beach at Surfers Paradise is some 30 – 50 m wider since mid 1999. In the vicinity of the reef, the net impact of the structure during the first complete 12 month seasonal cycle to January 2002 was to promote additional accretion of the updrift southern beach by up to 25 m for a distance of 450 alongshore, and 10 m of net beach accretion for a distance of 400 m on the down-drift northern side of the reef. During the most recent 6 month monitoring February - July 2002 a modest net erosion trend along the entire 4.5 km study area was observed. However a decreased rate of net shoreline recession was measured in the lee of the reef during erosion events, with a salient-like feature maintained in this localised region (Figure 1).

Figure 1. Beach width changes

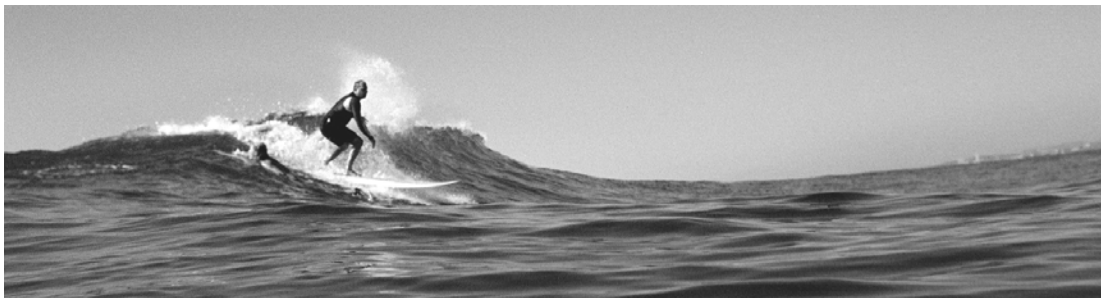
In average conditions, the waves tend to be more spilling (Photo 5) than plunging particularly at high tide - this best suits long boards and is preferable for safety and more inexperienced surfers. However, in larger swells with offshore wind conditions the waves can be hollow (Photo 6) and the crest bags can “suck dry” even with the lowered crest level. In one very large long period swell, the reef attracted tow-in surfers. The reef tends to provide a surfable wave even with an onshore wind when the break on the adjacent natural sand bars is choppy and closing out. The video monitoring shows a very high percentage of times when waves break on the reef but not on the adjacent bars. Wave breaking has proven to be relatively insensitive to gaps left where containers have deflated and a perfect surface is not required.

Photo 5. Spilling waves with swell under 1m

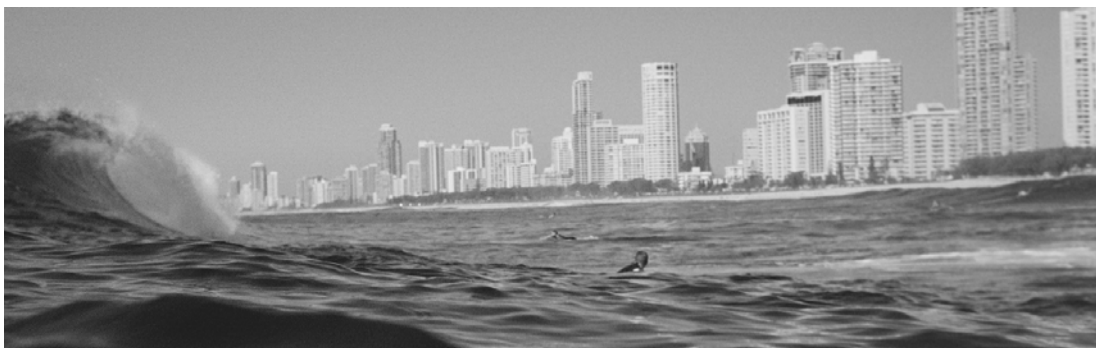
Photo 6. Hollow plunging wave with swell over 1.2m

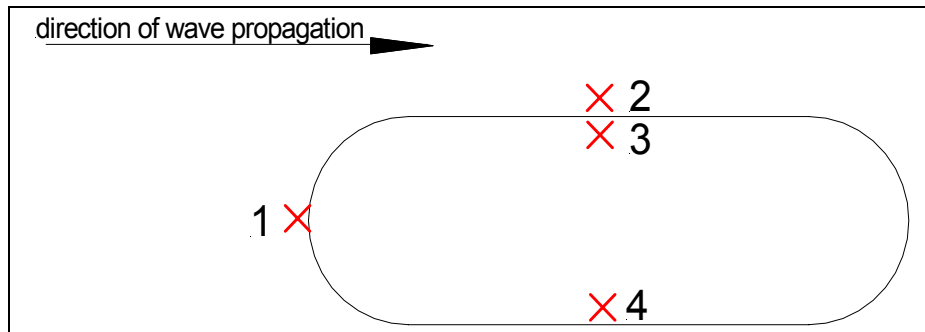
The sand containers appear to be hydraulically smooth with a low coefficient of reflection. As part of an undergraduate thesis (Corbett 2001) a trial container with pressure transducers on, and in it (Figure 2), was filled to approximately 80% capacity with sand similar to that used in the construction of the actual reef and sewn shut. The filled container weighed 696kg, was 1.5m in length, 0.9m in width and sat 0.5m high.

Figure 2. Location of pressure transducers

- (1) Attenuation of pressure fluctuations within the geotextile sand container is unhindered by the geotextile membrane, and is consistent with current theoretical models for wave-induced pressures in a horizontal seabed.
- (2) Lag of the transmitted pressure wave was essentially insignificant.
- (3) Due to the structure's response to wave-induced pressures, models developed for rubble mound breakwaters which assume that the structure is solid with respect to pressures should be used with caution
- (4) Liquefaction, combined with horizontal differential pressures, provides a mechanism for the investigated failure mode.
- (5) To control this mode of failure, appropriate filling and container shape is essential.
