# REMOTE DIAGNOSIS OF LEAKAGE IN RESIDENTIAL HOUSEHOLDS

T Britton, G Cole, R Stewart, D Wiskar

## Abstract

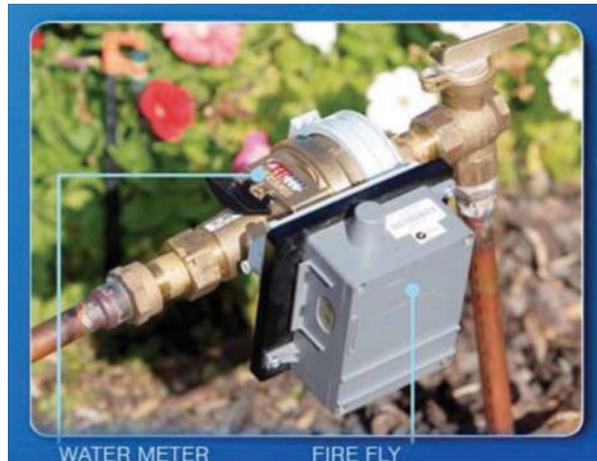
Figure 1. FIREFLY® and Water Meter installation at residential property.

All domestic meters in Hervey Bay have been replaced with new Elster V100 meters that have a FIREFLY® data logger attached (Figure 1). The FIREFLY® records a magnetic pulse from the meter at a rate of one pulse per five litres. These units are capable of recording hourly flow data, and transmit to a receiver on a hand-held computer or in a drive-by unit. The logger can store six reads at four hour intervals each day for a minimum of 120 days. The battery life for the logger and transmitter is expected to last for a minimum of five years.

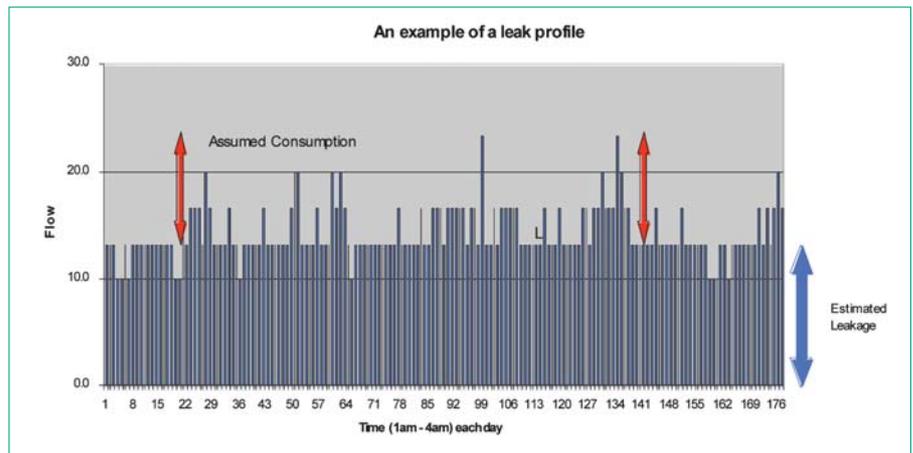
Figure 2. An example of a leak profile.

On 23rd October 2007, 2,359 residential meters were read in Point Vernon; 47 meters flagged a trickle alert; Figure 2 illustrates the location of each leak. Profiles of the 47 meters were downloaded providing information on water use for the previous 177 days. The raw data was examined; this provided hourly, daily and monthly data for each meter. In order to assess flow rates and total leakage post-meter, the leakage component had to be separated from consumption. Each meter was analysed individually each day between 1am - 4am to obtain an average minimum night flow. The information was converted to a graph, illustrating a leak pattern as illustrated in Figure 1. The most consistent level of the flow was assumed to be the leak rate, and spikes were considered to be elements of consumption. The average flow rate for those 3 hours minus estimated consumption was assumed to be the average leak rate per hour - this leak rate was subtracted from the consumption volume in each hour of the day. This allowed us to monitor the consumption versus leakage and estimate hourly losses.

The leak pattern provides a visual display of the leakage occurring over a time frame. Table 1 shows the total consumption of all meters in Point Vernon and the 47 meters as a percentage of the total. The hourly consumption between 1am and 4 am highlights that 2% of meters account for nearly 24% of recorded consumption during that time.

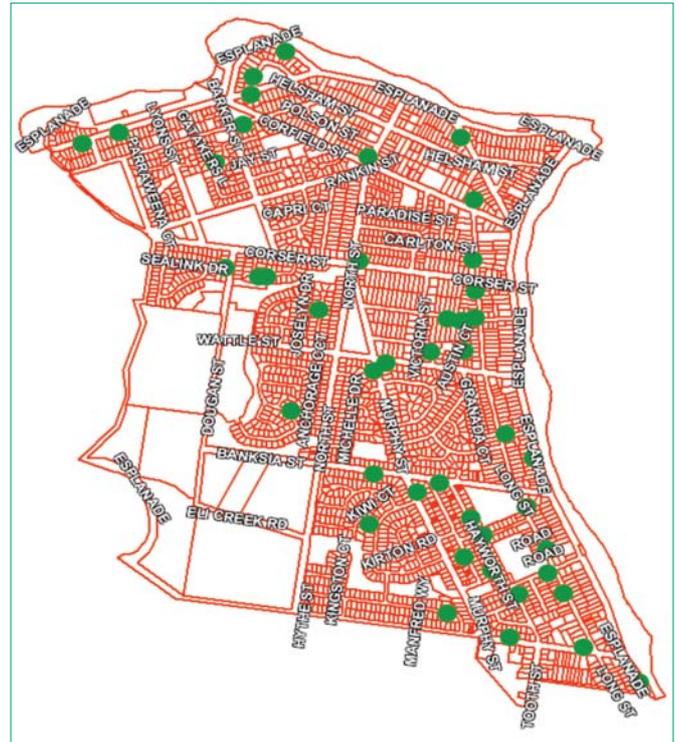
**Figure 3. Location of Leaking Households in Point Vernon DMA.**

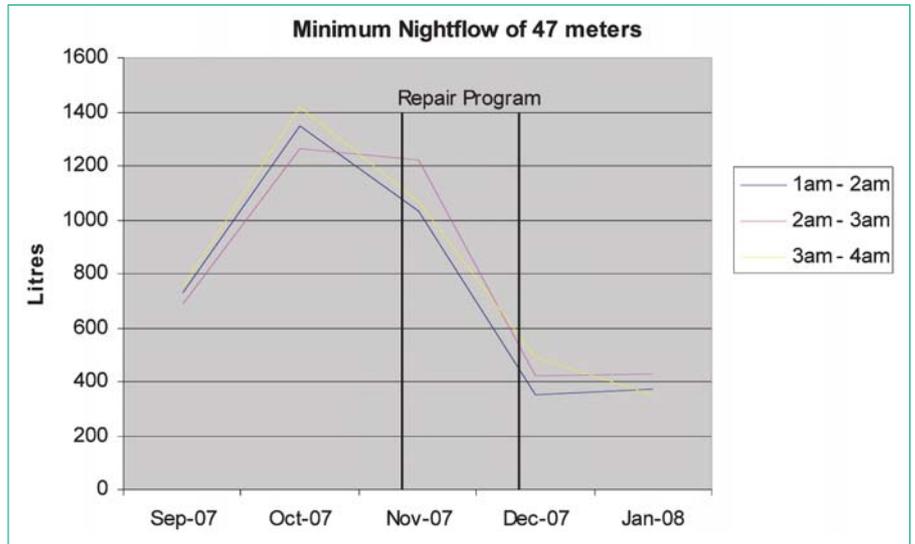
**Figure 5. Change in minimum night flow as a result of the repair program.**

The meters were read again on 20 January and the combined night time leakage/consumption of those 47 households had reduced from ca. 1300 to 356 litres per hour. In 11 (23%) of the households the leakage STILL accounted for over 70% of their daily metered consumption. Since 20 January, three more households have been repaired which brought the minimum night flow down to an average 173 litres per hour. Six households that did not respond to communication no longer had leaks; it is assumed they undertook their own repair.

Therefore the general savings as a result of the program is 1095 litres per hour. Fig 4 illustrates the change in minimum night flow as a result of the repair program. The total cost of the program including project management and staff time was \$5,168.27 (excluding rebates); materials accounted for \$448.22. If the properties had been allowed to continue leaking at the rate of 1095 litres per hour then the water lost would amount to 26,280 litres per day and 9,565,920 litres per year.

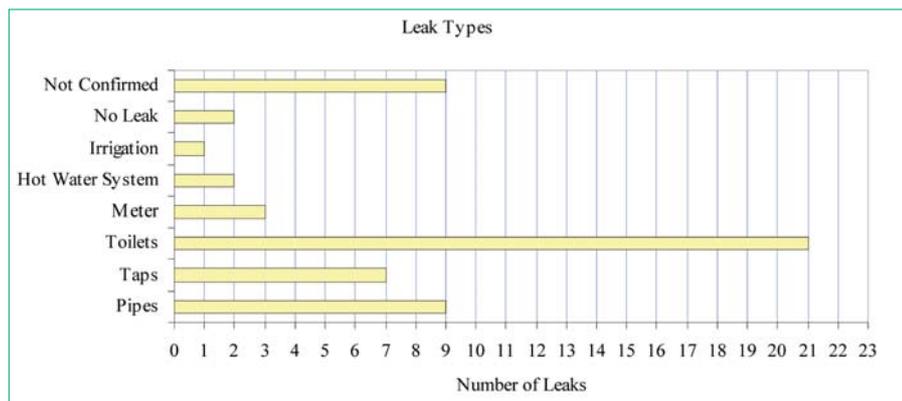
Figure 7. Type of Leaks Identified.

This study identified seven major types of leaks, Fig 5 illustrates the number of leaks by leak type, among them toilet leaks represent 46%. The following sections discuss each leak type in detail.
