# Noosa Main Beach Algae Mitigation Trial

Noosa Main Beach (Sunshine Coast, Australia) experienced large volumes of filamentous algae *Hincksia sordida* during the summer months for three consecutive years. Visually unappealing and producing an obnoxious odour, it has a significant negative impact on the local tourist-based economy. Traditional methods of dealing with the algae were unsuccessful and alternative options were generated, culminating in the trial of a seabed based curtain in 2009.

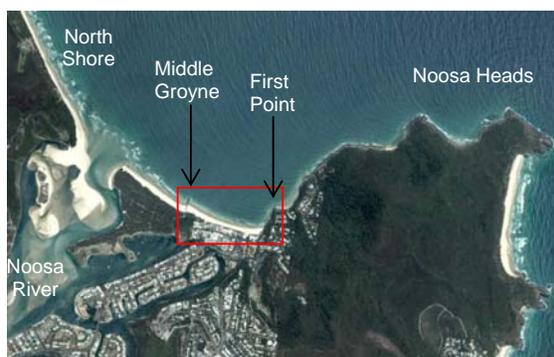
Figure 1: Area of Exclusion on Noosa Main Beach (Image Source: Google)

The Noosa Main Beach Algae Mitigation Project was initiated in 2005 in response to the repeated presence of algae during the summer months at Noosa (Sunshine Coast, Queensland, Australia). While the source of the algae bloom was investigated, the aim of this project was to investigate ways to exclude the algae from Noosa Main Beach between First Point and the middle groyne (Figure 1).

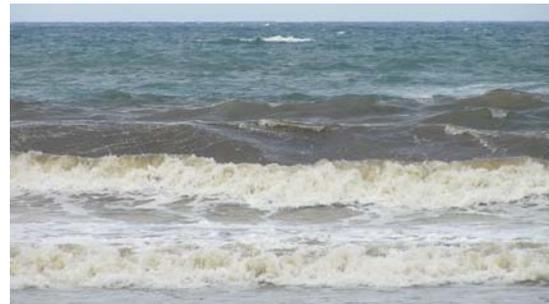
Figure 5: Algae present over the width of the surf zone

Preliminary observations indicated that pockets of algae were distinct, restricted to the width of the surf zone (Figure 5) and to defined areas alongshore which appeared to correlate with rip cells. Within this region, the alga was well distributed through the water column by turbulence generated by wave action.

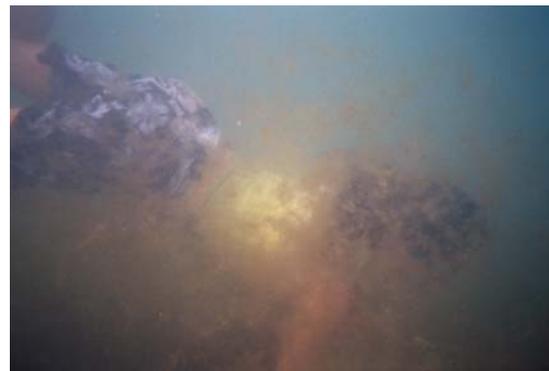
Figure 6: Very high concentrations of algae at the seabed directly seaward of the surf zone.

Directly seaward of the surf zone, while the water appeared clear, further inspection revealed that algae was evident in very low concentrations throughout the water column, with very high concentrations within  $\sim 10-20cm$  of the seabed (Figure 6). Further seaward, the layer close to the seabed remained evident, with variations in concentration becoming more distinct so that 'patches' of algae became more defined (Figure 7).

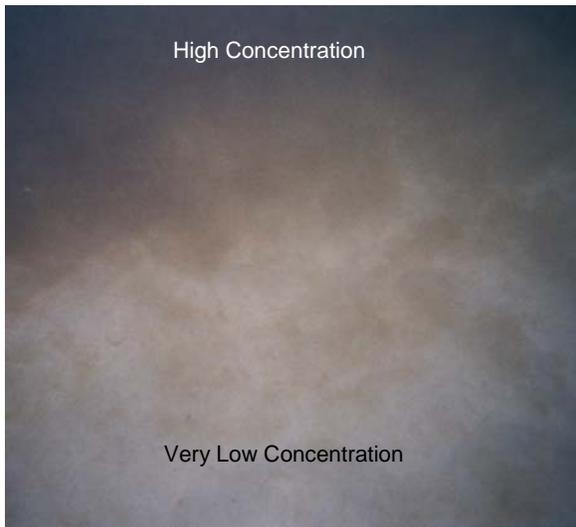
Figure 7: Patches of higher and lower concentration of algae slightly further seaward

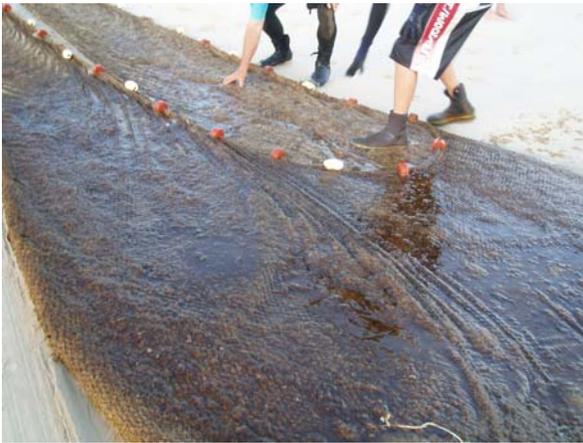
Figure 11: Algae removed from water using 20mm mesh fishing net.

A 40m long x 1m wide 20mm mesh fishing net was handled by two people in the surf zone and removed from the water using a 4WD (Figure 11). The 20m length appeared noticeably clearer, but the volume of algae removed and successfully cleaned from the net was only  $\sim 0.25\text{m}^3$ . Standard procedures for net cleaning proved ineffective and a significant amount of algae was unable to be removed effectively from the net (Figure 12). Subsequent attempts were less effective as the net was already clogged with algae.

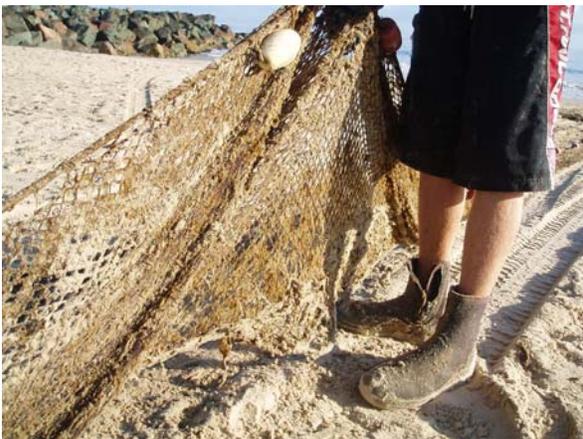
Figure 12: Mesh was clogged with algae and could not be easily cleaned.

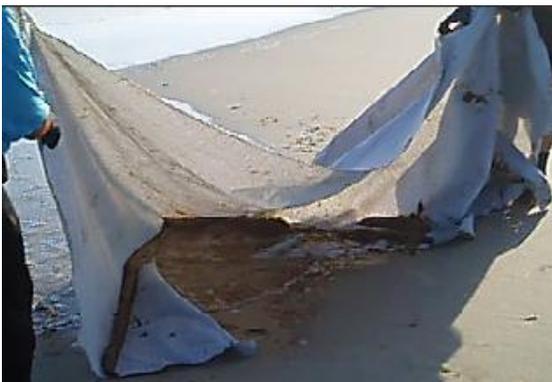
Figure 13: Algae rolling off the shade cloth

A 3m length of shade cloth was also trialled. A similar volume was removed (per metre of net), but unlike the mesh, the cloth was easily cleaned as the algae rolled off the fabric (Figure 13).

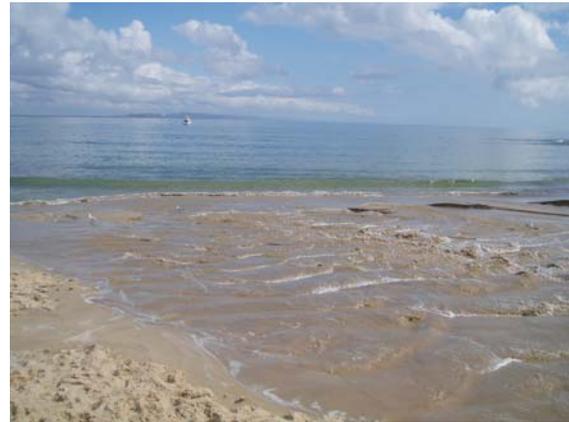
Figure 14: Clear water directly seaward of the Sand Shifter discharge point

The operation of the local sand backpassing operation (Sand Shifter) provided the only real low-impact mechanism for influencing current patterns that may disperse the algae. While there was a patch of clear water directly seaward of the Sand Shifter (Figure 14), a dense patch of algae was evident within 30m of the discharge point. As such, it was concluded that the effect was relatively localised and the lack of people utilising this section of beach made it clear that the discharge was not successfully creating a desirable swimming location.

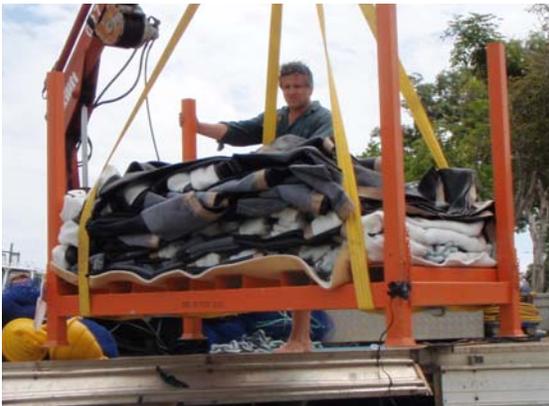
Figure 15: Seabed based algae curtain prior to installation

The seabed based curtain was fabricated by ELCO Solutions in 2005 (Figure 15), however the algae season finished early and did not appear in subsequent seasons, so the installation of the curtain was delayed. In 2009, the newly formed Sunshine Coast Regional Council decided to deploy the curtain as a proactive measure to ensure that installation could be undertaken smoothly when required. The curtain was successfully deployed by Marine Civil Contractors in March 2009 (Figure 16).

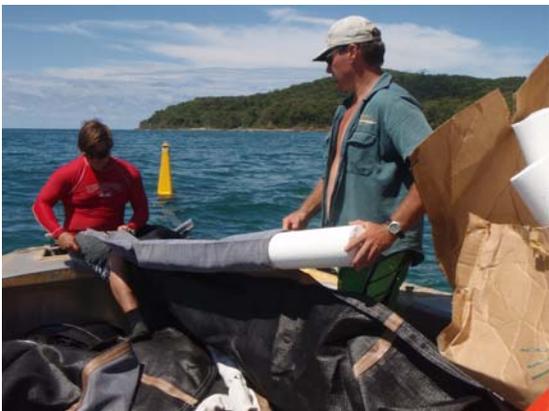
Figure 16: Final assembly and deployment of algae curtain

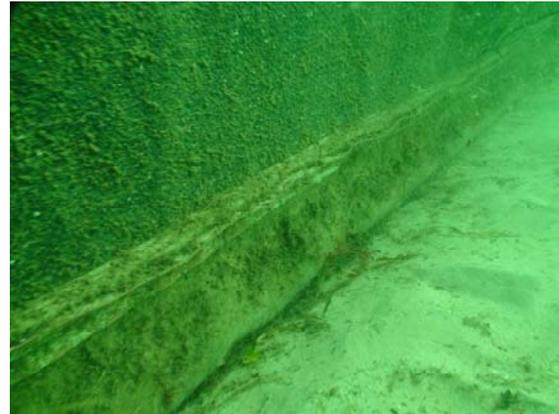
Figure 17: Seabed based algae curtain resting on seafloor

The curtain was deployed in water depths between 3.8 – 4.5m LAT, giving ~3m clearance above the curtain at all times. Once deployed and pulled into position, the curtain sat vertically in the water column with the centre of the chain at the seabed level (Figure 17) and the top of the curtain moving horizontally by up to ~0.5m during the sets ( $H_{max} = 1.3m$ ). These observations suggested that preliminary design was reasonably accurate.
